Dell™ PowerConnect™ 6224/6224F/6224P/6248/6248P

**Firmware Upgrade Procedure From
Version 3.x.x.x to 3.3.18.1**

Date: Feb 2019

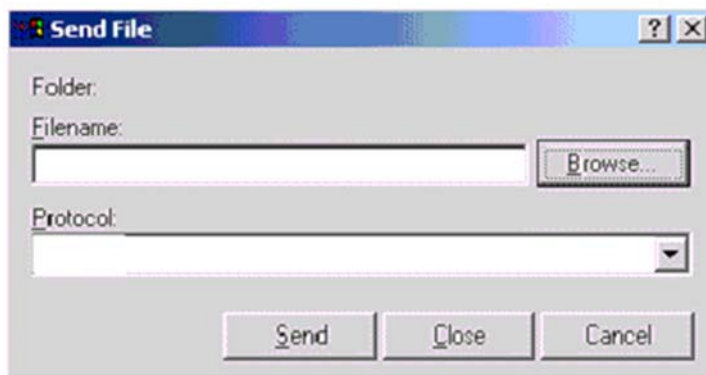
8. Using any VT100 emulator (Windows HyperTerminal shown here), select the download file option. The **Send File** window is displayed. Click the **Send** button.

9. Enter the path and filename for the software (for example: PC6200v3.3.18.1.stk)
10. Ensure the protocol is defined as XMODEM (use Xmodem-1K if available for much quicker download)
11. Click **Send**. The software is downloaded.
12. Once the download is complete (this may take an hour or longer), select **7** to **update boot code** from the boot Menu and then enter **Y** to reset the switch
